Manhole Inspection Summary

Manhole # S31A__036MH

Insp Date: **12/20/07 1:17 PM**

Location Address: **601 PACA ST**

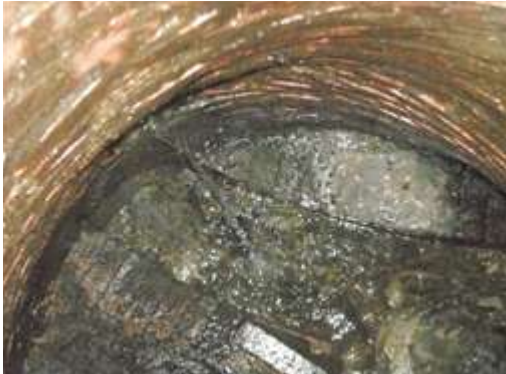
Defect 1

☒ **Evidence Of Surcharge** Depth: **6** (ft.) ☐ Active Surcharge Present

DEBRIS ON BENCH - EVIDENCE OF SURCHARGE

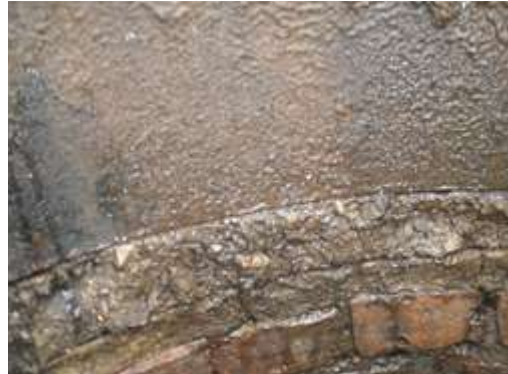
Defect 2

Condition: ☐ Sound ☒ **Cracked** ☐ Root Intrusion ☐ Loose Brick ☐ Deteriorated

CRACK IN CHIMNEY

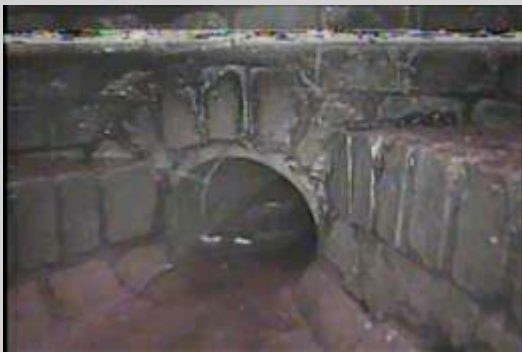
12 O'Clock Outflow

Pipe Height: **7.2** (in.) Rod and Bar (Angled)
Pipe Material: **Clay** ☐ Pipe Lined
Invert Depth: **11.68** (ft.) Flow Characteristics: **Slow**
Deposits: ☒ None ☐ Mud ☐ ~~Gravy~~ ☐ Debris ☐ Grease
Silt Depth: (in.) Deposits Extent:
Infiltration: **None** Pipe Seal Cond: **Sound**

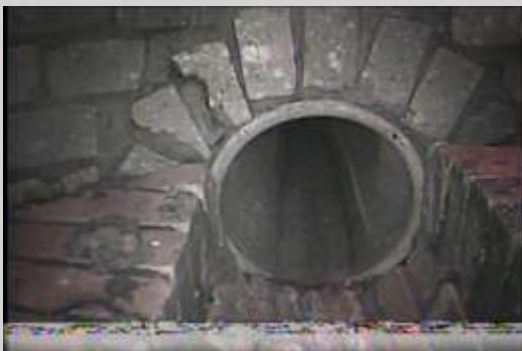
4 O'Clock Inflow

Pipe Height: **8.4** (in.) Rod and Bar (Angled)
Pipe Material: **Clay** ☐ Pipe Lined
Invert Depth: **11.13** (ft.) Flow Characteristics: **Slow**
Deposits: ☒ None ☐ Mud ☐ ~~Gravy~~ ☐ Debris ☐ Grease
Silt Depth: (in.) Deposits Extent:
Infiltration: **None** Pipe Seal Cond: **Sound**

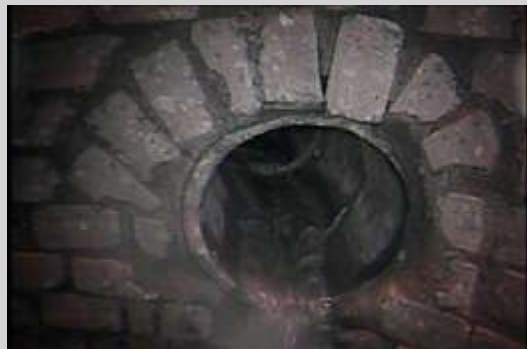
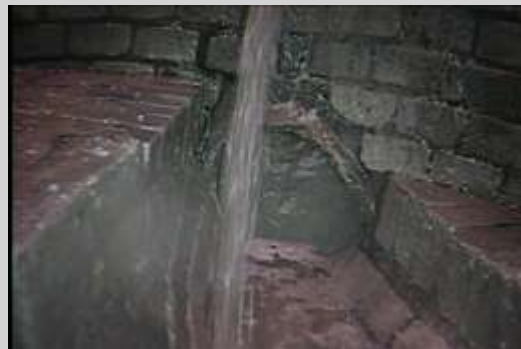
8 O'Clock Inflow

Deposits: ☐ None ☐ Mud ☒ **Sludge** ☐ Debris ☒ **Grease**

Silt Depth: **3** (in.) Deposits Extent: **Medium**

Drop: **Outside** Rod and Bar
Angled: **Yes** Reading: **10.60** (ft.)
Inv Depth: **11.60** (ft.)
Drop Condition: **Clogged**
